AVIATION INVESTIGATION REPORT

A00A0051

COLLISION WITH TREES

ISRAEL AIRCRAFT INDUSTRIES ASTRA SPX

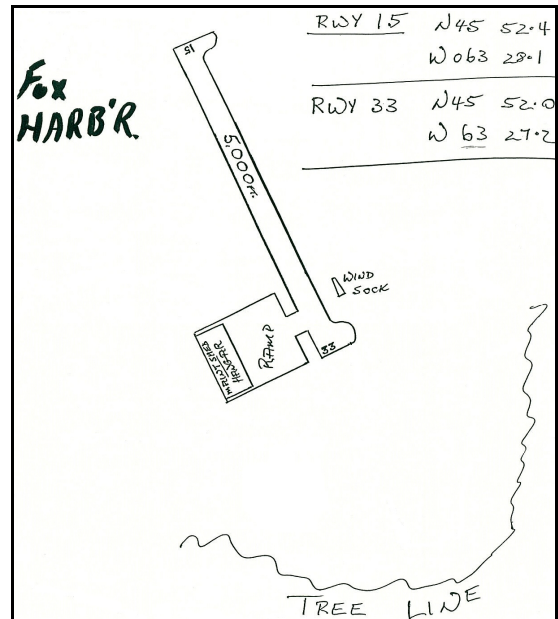
Figure 1 - Hand-drawn diagram of Fox Harbour aerodrome

The aerodrome information available to the crew for the approach was a hand-drawn sketch of the aerodrome layout, with the latitude and longitude coordinates noted (Figure 1). The crew could not obtain current runway condition or wind information because the VHF radio at the aerodrome was not staffed.

- (a) The runway has been surveyed and centreline markings have been made in accordance with accepted standards.

- (b) A PAPI (precision approach path indicator) has been installed at both ends of the runway, and the calibration is confirmed weekly.
- (c) ARCAL (aircraft radio control of aerodrome lighting system) has been installed to control runway lighting and the PAPI.
- (d) The trees on the Runway 33 approach have been cut back to comply with the approach standards set out by Transport Canada.
- (e) A rotating beacon has been installed on the hangar and comes on when the ARCAL is activated.
- (f) A global positioning system approach is being developed by Approach Navigations Systems Inc. and Transport Canada approval is expected in the near future.
- (g) Standard operating procedures have been put in place for all company aircraft operating in and out of the Fox Harbour aerodrome.
- (h) Fuel is available at Fox Harbour, facilitating lower aircraft landing weights.
